# Performance of Glass Fiber-Reinforced Polymer Reinforcing Bars in Tropical Environments— Part II: Microstructural Tests

by Abhijit Mukherjee and S. J. Arwika

*In the first part of this study, the structural scale tests on the synergistic effects of moisture, temperature, alkalinity, and stress level on the performance and durability of glass fiber-reinforced polymer (GFRP) reinforcing bars in concrete have been discussed. In this part, investigations on microstructural studies, carried out to find out the nature, quantum, and mechanism of deterioration in the conditioned reinforcing bars, are reported. Micrographic investigations were carried out using a scanning electron microscope (SEM) to visualize the changes in the microstructure. The other tests that have been carried out are energy-dispersive x-ray analysis (EDX) and inductively coupled plasma mass spectrometry (ICP-MS) to determine the chemical changes in the composite.*

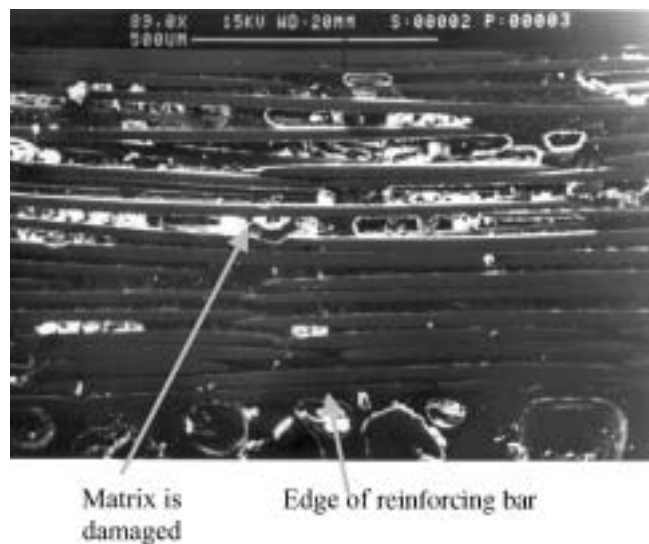
Fig. 6—Damaged area on outer layer of GFRP reinforcing bar (B3-900).

the fiber. A magnified (890 $\times$ ) view near the reinforcing bar surface is shown in Fig. 6. The voids are created along the length of the fiber/reinforcing bar. In this sample, the maximum damaged zone is 250  $\mu\text{m}$  inside from the surface of the reinforcing bar. At this stage, the matrix is damaged much more than the fiber. Further, it can be seen in Fig. 6 that an approximately 600  $\mu\text{m}$  length of the matrix is damaged at a distance of 400  $\mu\text{m}$  from the edge of the reinforcing bar. The major areas near the edge are unaffected. Thus, the damage to the matrix is local in nature.
